TRANSMITTAL OF CLOSE OUT REPORT FOR OFFICE TRAILERS T130D, T130F AND
T130H -- DWF-095-05

Type 1 Facility Closeout Report

Facility No.	T130D, F, H
Facility Descriptor:	Office Trailers, 46,200 square feet
Project:	RISS - Area 5 D&D
Date of Demolition:	August 31, Sept. 6, Sept. 8, 2005 (respectfully)
Additional Information:	Modular corrugated metal office trailers demolished and disposed of as sanitary waste.

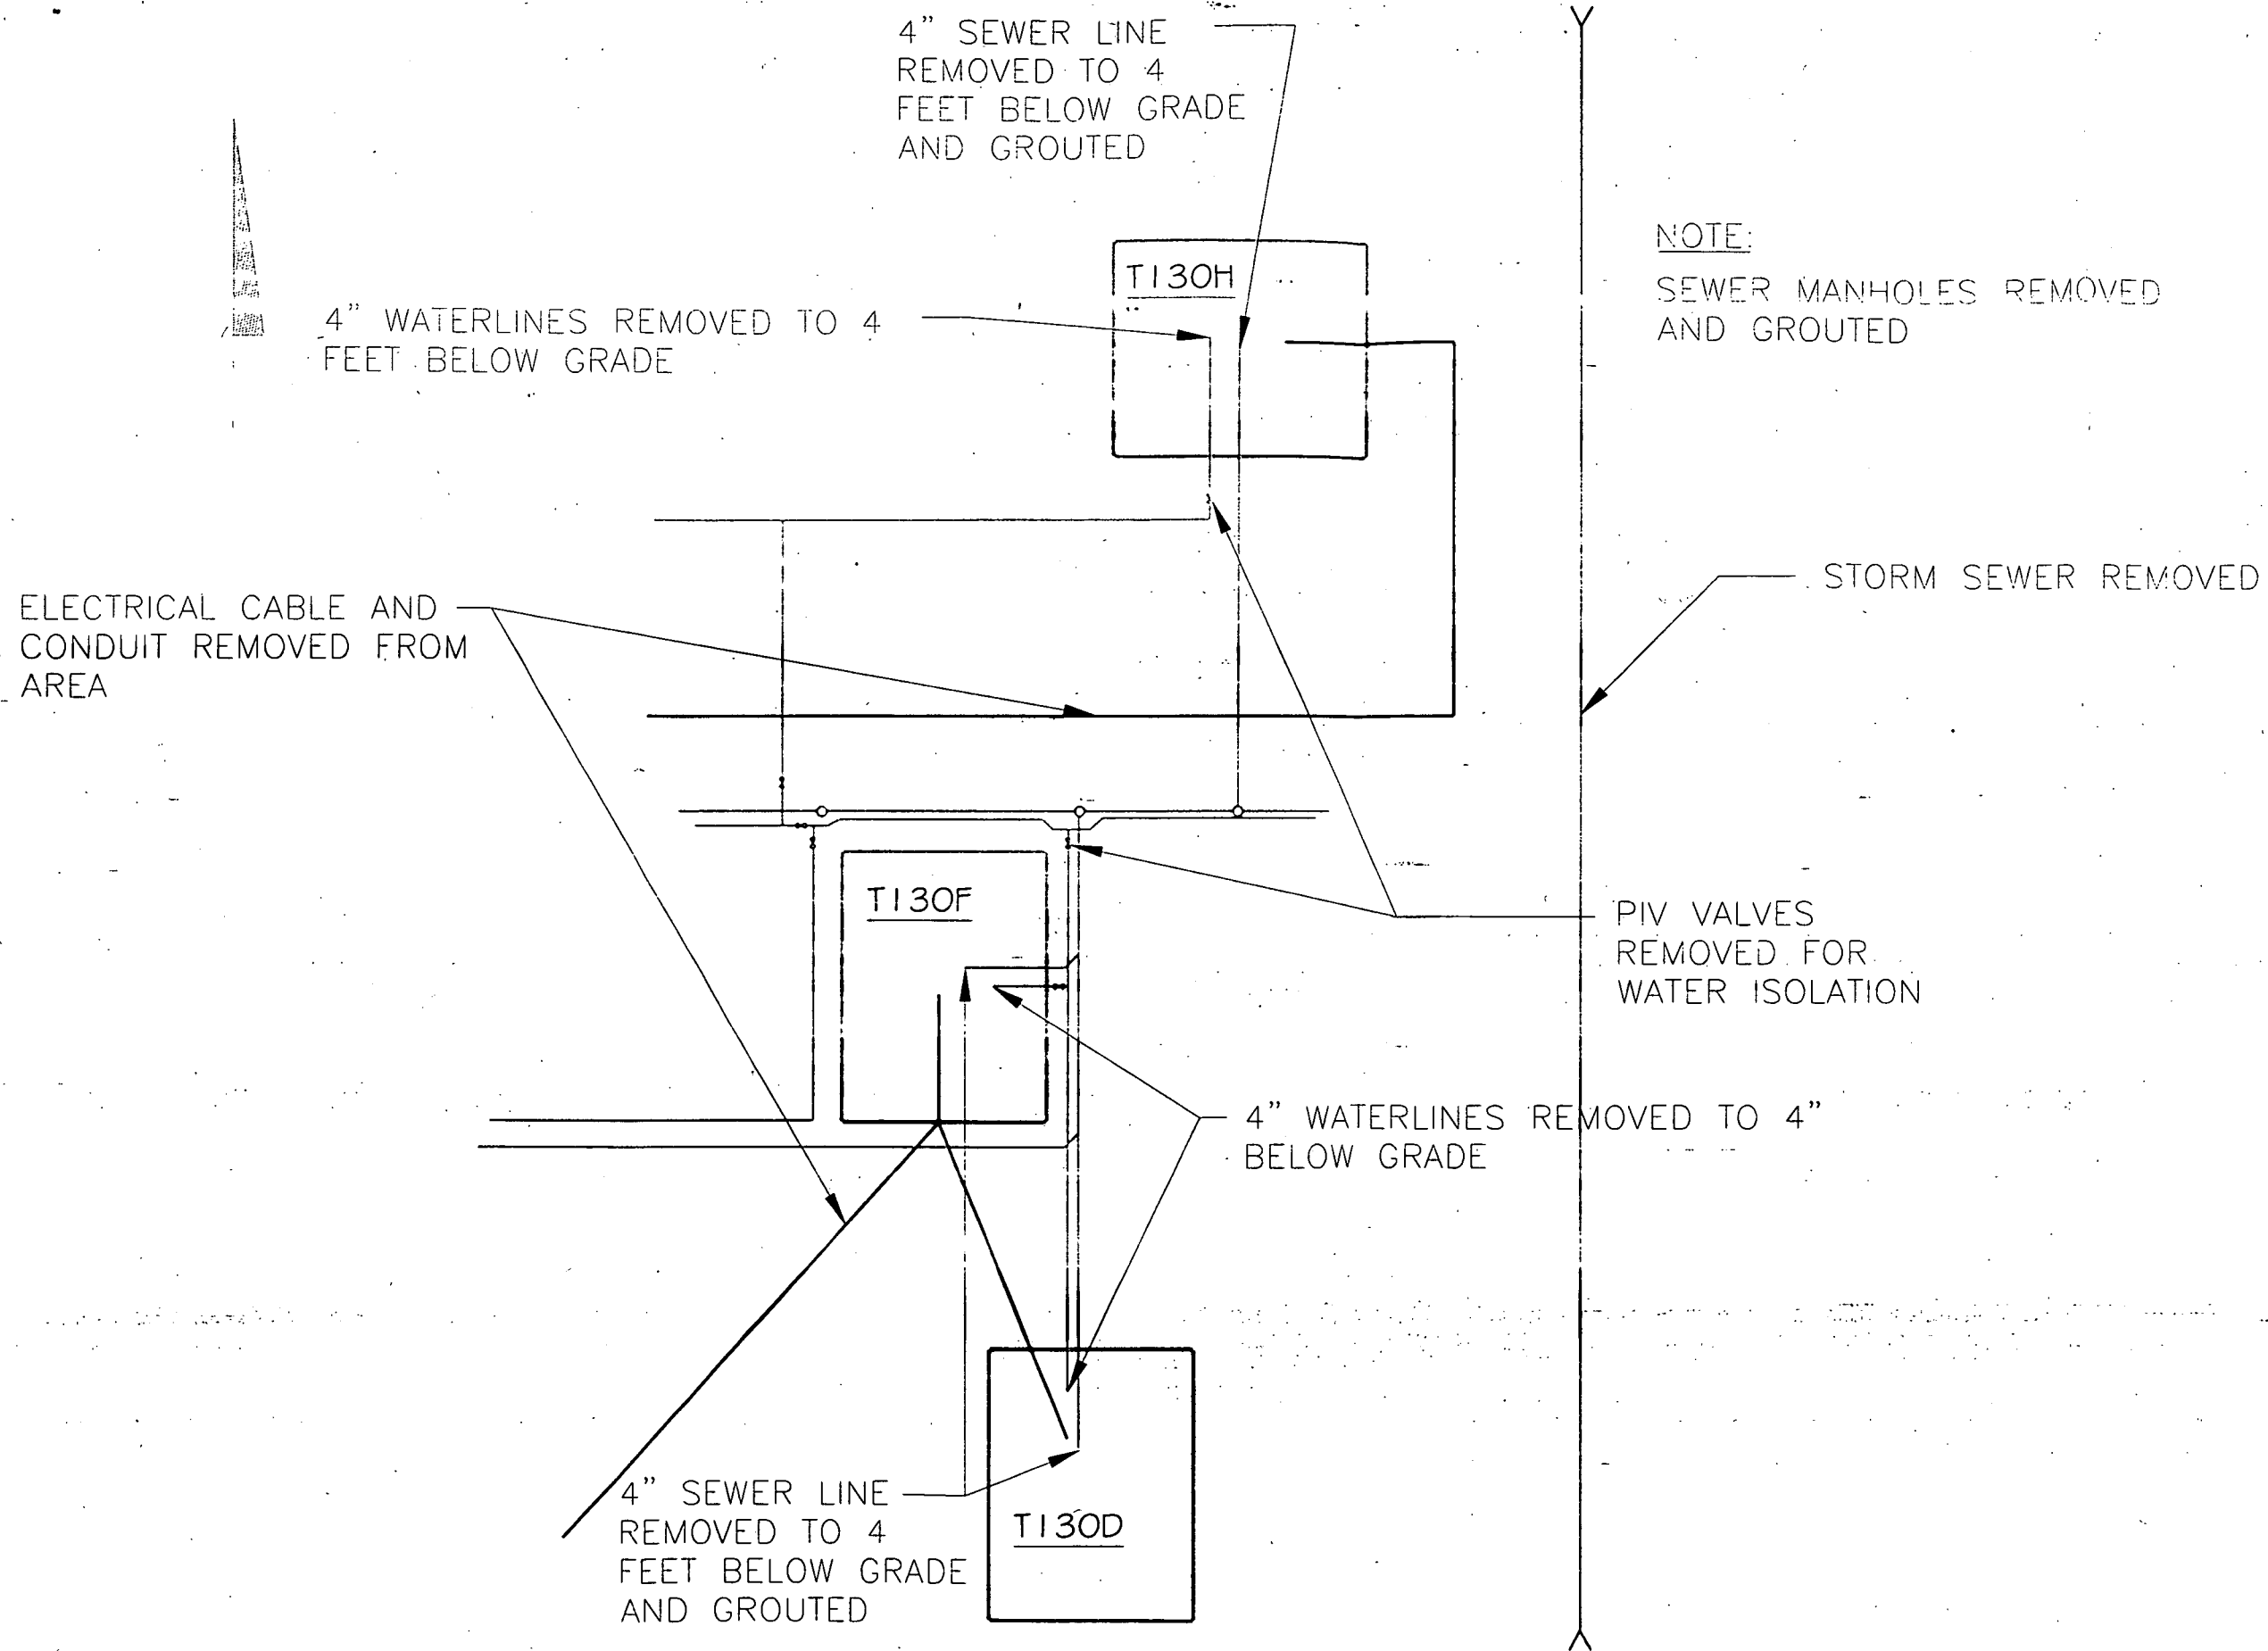
T130 TRAILERS - D, F & H

All three trailer structures were removed during D&D activities, and sent offsite for disposal. The utilities were disconnected and removed to at least three feet below final grade as indicated on the attached map. There are no remaining structural components, utility lines, or parts of the foundation. The buildings are not in an IHSS or PAC therefore no soil sampling is required.
